Champaign County Old Courthouse Renovation

Urbana, Illinois

Client: Champaign County
Architect: Isaksen Glerum Architects, Urbana, IL
Construction Manager: P.K. Demars., Champaign, IL

Exterior Renovation

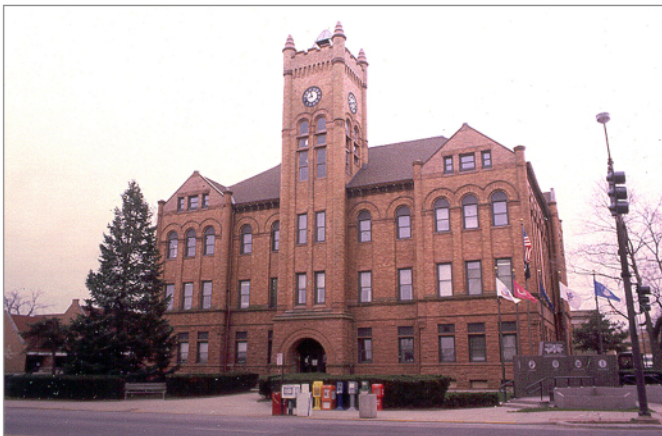
1

The existing floor framing system in the old 38,000 GSF courthouse consisted of flat tile arches spanning between steel beams with lightweight concrete topping, image 1. Existing floor depths varied from 12-inches to 20-inches. The structural portion of the INTERIOR renovation included designing new lintels for new openings in the massive masonry walls to accommodate the revised architectural floor plan. The new wall opening sizes varied from 4-feet to 8-feet. Large floor openings at an existing open stair well at the second and third floors as well as a large mechanical opening at the third floor were infilled with new steel framing and concrete slabs. A structural planning exercise permitted the architect's idea of a new concrete block enclosed stair well from the first floor to the attic by removing a section of the old floor framing at the second and third floors. A new double level mechanical platform was created in the attic by the design of two new steel trusses spanning 35-feet. Three years preceding the major masonry renovation, a section of badly deteriorated 30-foot long upper west exterior brick bearing wall (image 2) was removed and replaced and the sagging steel roof framing at this location was plumbed and leveled. Image 3 shows the exterior side re-alignment of stone cornice and new steel back-up. Our office engineered and coordinated that effort. Continued on page 2.

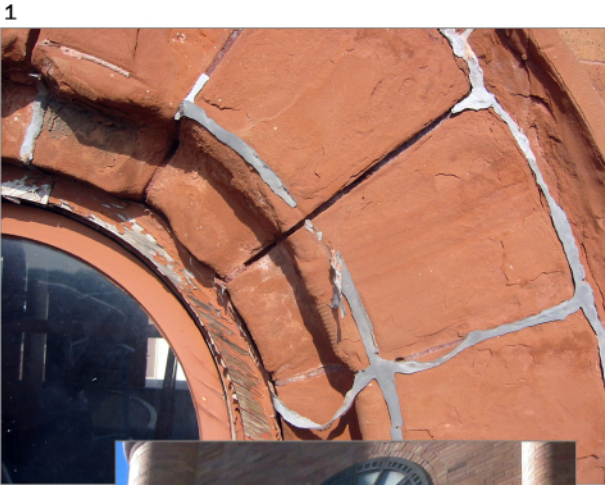
Renovation was limited due to the project budget. The exterior historic masonry renovation focused on the upper tower window area where sandstone units were severely eroded (image 1) and some units had fallen out leaving large, open gaps in the wall.

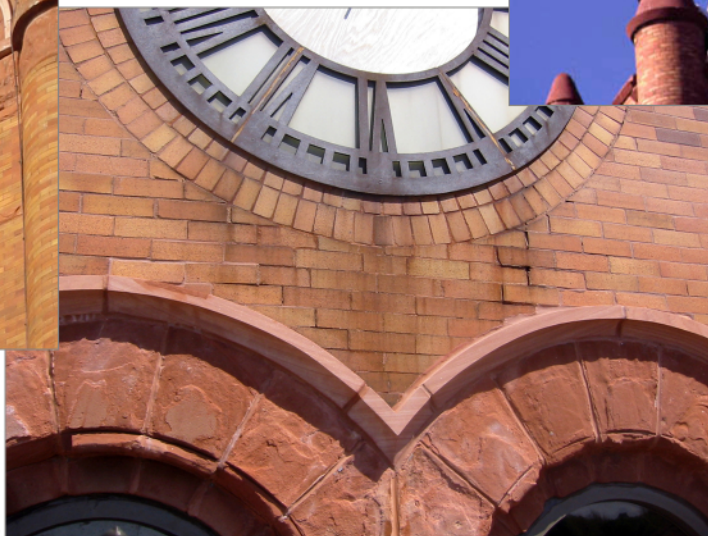
Image 4 was taken during the punch list review after all items were cleaned, glazed, patched and re-pointed. Fractured turret pieces were replaced on the tower by crane. See images 5 and 6.
