Fischer Theater Structural Condition Investigation

Danville, Illinois

Client: Vermillion Heritage Foundation, Danville, IL

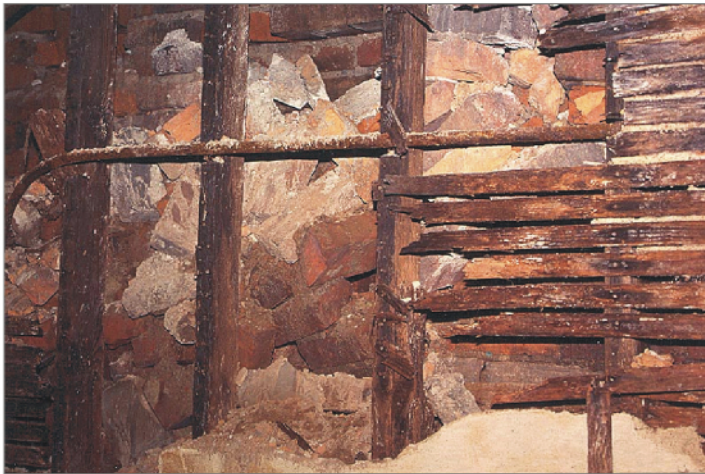
Present South Wall Condition

Water has been entering the wall for many years. The salmon brick units, intended for interior usage, have disintegrated and the mortar has turned to powder in the lower regions of the three story wall. Parts of the wall have already collapsed behind the recessed wood stud wall and plaster coating. The wall is a bearing wall that supports the main roof trusses and is unstable and poses a threat to public safety. See image upper left.

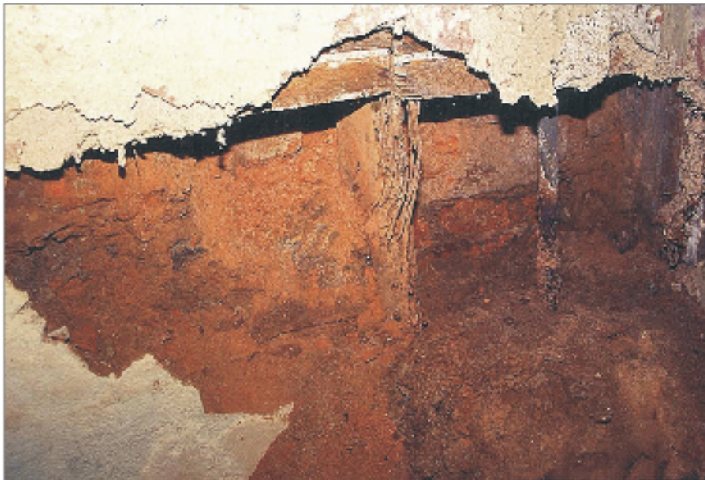
Present North Wall Condition

The north wall is considerably thicker and more detailed on the exterior since it faces the street. It has more structural integrity than the south wall. Termite activity has deteriorated the inner recessed wood stud wall segments. See image lower left.

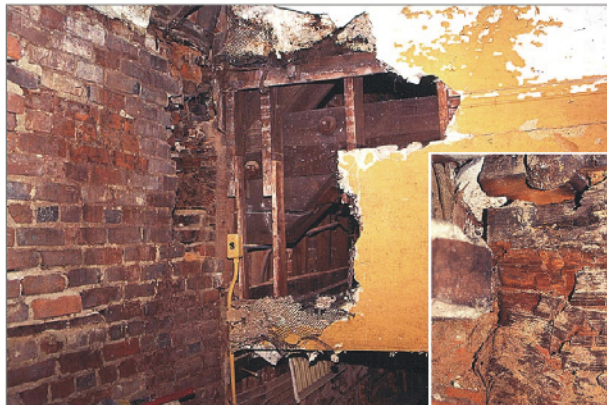
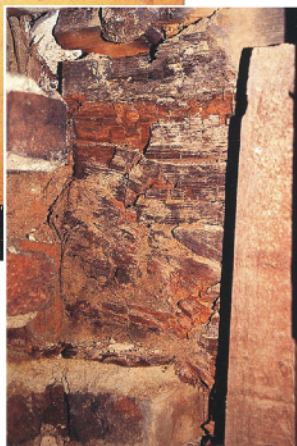
Condition of the East Roof Truss

The South-bearing end of the timber truss is rotted, crushed and rotated (see overall image far left and close-up inset image of bottom chord). Large chunks of wood can be removed by hand. The bolts are tilted and unable to hold the parts together. The north bearing end sits on three studs of the wood stud recessed wall, rather than the masonry. The truss reaction has crushed the top plate into the central stud, causing the truss end to drop 1 inch and fracture the wood top plate (see lower inset image to left). The adjacent brickwork has fractured, rotated and displaced as a result of the truss drop.

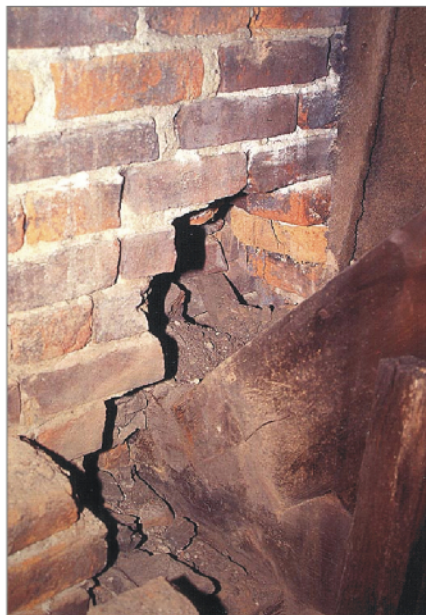
Middle Truss

Condition of the Middle truss

The middle truss south bearing end was also rotted and displaced downward, much like the east truss (see lower left image).

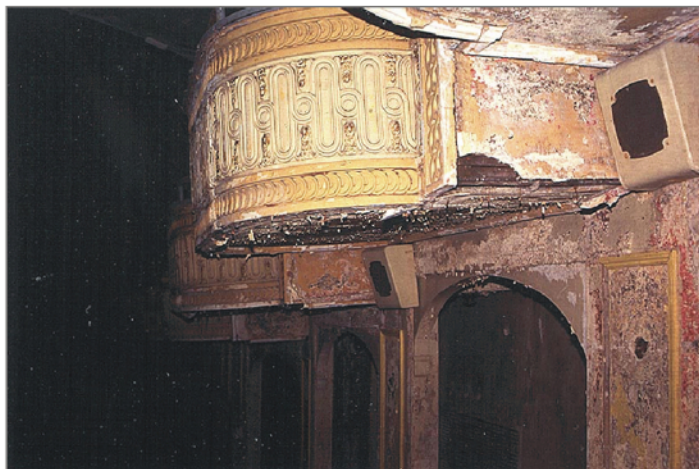
Lower Balconies

Condition of the Lower Scalloped Balconies

The side balconies are wood framed and cantilever off the brick wall below. The backspan frames into a ledger board anchored to the exterior south wall. The balconies have sagged visibly and flex when standing on them. Creep in the wood has led to permanent sag. Collapse of the south wall will collapse the balconies (see image below).
