First United Methodist Church Structural Repair of Roof Trusses

Paxton, Illinois

Project Overview

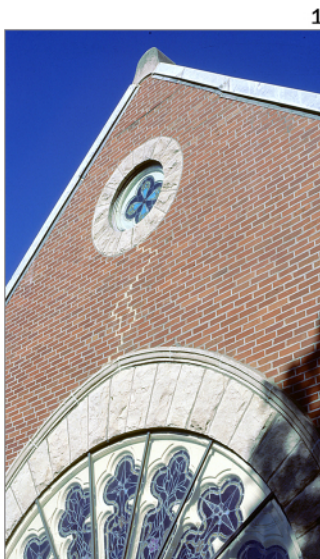
1

The roof form of the First United Methodist Church in Paxton, IL is composed of intersecting gables at a 12 in 12 slope (image 1). Two parallel 45-foot span scissors trusses, spaced approximately 40 feet apart, support the gables. Two parallel chord trusses running in the perpendicular direction and spaced approximately 11 feet apart are suspended from the scissors trusses. All roof rafters bear on these parallel chord trusses. Thus the two scissors trusses support the entire roof. The scissors trusses run parallel with the roof rafters and there is no connection between the roof plane and the trusses. The top chords of the trusses are built up from (5)-2x10 dimension lumber pieces spiked together. The members perpendicular to the top chord are also built-up dimension lumber, while the bottom chord is composed of (2)-1-1/2 inch diameter wrought iron rods. The tension diagonals are also rods. The top chords have buckled under the axial compression force and the pieces have separated, allowing further weak axis bending (image 2). Creep in the wood has increased the weak axis deformation beyond 6 inches. The wood diagonals are twisted to follow the top chord curvature at one truss (image 3). The wood diagonals have shifted out of alignment in trying to follow the top chord curvature at the other truss (image 4).
