Loomis Laboratory Masonry Rehabilitation

University of Illinois
 Urbana, Illinois

Client: Capital Development Board, Springfield, IL
 Prime A/E: Glerum Wachter Architecture, Urbana, IL

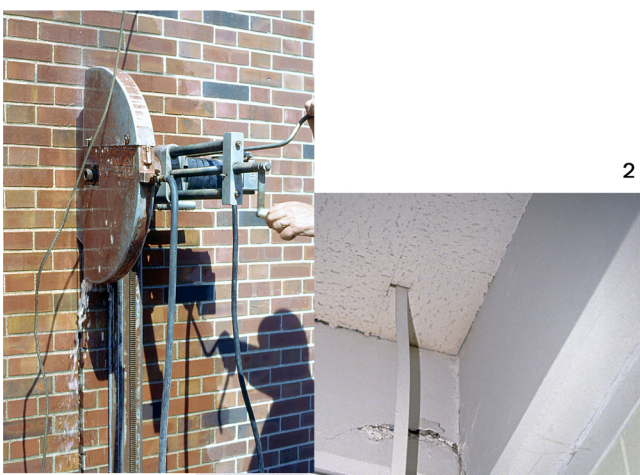
2

The brick expanded in both the horizontal and vertical directions, starting from the center of each elevation and grew out to the corners horizontally, and growing vertically bending shelf angles and raising the parapet copings. The horizontal expansion pushed the brickwork off at the corners, bending and displacing the brickwork and creating major veneer fractures as shown in image 1. The Header bonding to the backup forced the middle and inner wythes to be dragged with the expansion and push against the corner columns. This resulted in column/spandrel beam fractures at all four corners in the upper two floors. See image 2.

The scope of the repair work included:

1. Saw-cut vertical expansion joints (see image 3) uniformly spaced around the building.
2. Repair/replace existing damaged brickwork and add shelf angles where omitted.
3. Replace parapet coping joints with sealant to prevent water from entering the walls.
4. Repair damaged corner columns with epoxy injection to restore column strength.
5. Anchor existing brickwork in areas without adequate ties to the backup.
6. Replace existing torn or hardened caulk.
7. Install missing flashing at all existing horizontal shelf angles.
