The Wolford Apartment Building Masonry Restoration Project

Danville, Illinois

Client: Urban Innovation, Inc. , Chicago, IL
 Architect: BLDD Architects, Decatur, IL
 Masonry Contractor: Otto Baum Company, Inc., Morton, IL

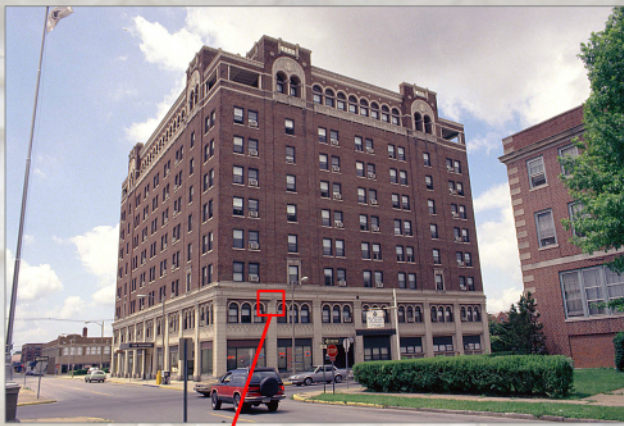
One repair project was implemented in 1986-7: repair of the corner apartment porches. This centered on the terra cotta spandrel that was drooping at three corner apartments, see image A. The terra cotta was removed; the corroded supporting steel pieces were replaced and then the terra cotta was re-hung. See page 2, images 1 and 2. Parapet level brickwork that was water damaged and bulging was replaced on two elevations.

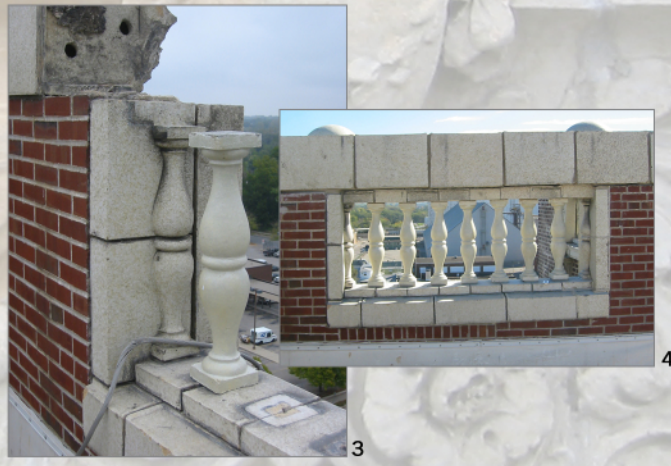
There were many locations on the building where the brick work mortar joints had been severely eroded. The brick work below the large terra cotta coping units was starting to spall and loosen due to improper joint repair between the large terra cotta units. Several terra cotta units on the roof were beyond repair, such as balustrade elements – these were replaced with glass fiber reinforced concrete units with a glaze coating to match the aged terra cotta finish. See image 3 and 4. All of the terra cotta coping units were removed, flashing added and the terra cotta coping units were anchored to the top of the wall with stainless steel anchors. The owner elected to repair only the severely deteriorated mortar joints. Matching mortar colors were selected for the brick joints and the terra cotta mortar joints. Several of the large ornate terra cotta units on the lower level band had large sections missing. Several existing terra cotta units were beyond repair and 35 replacement units were ordered at a cost of \$40,000. Jahn patching mortar with Edison glazing paint was used for several spalled terra cotta units, such as image B on page one. The mason was able to copy the ornate carving using the patching mortar to save column capital B, image 5.
