First United Methodist Church Masonry Restoration and Repair

Champaign, Illinois

Client: First United Methodist Church Board, Champaign, IL
Construction Manager: Broeren Russo Construction Company,
Champaign, IL
Masonry Contractor: Otto Baum Company, Inc., Morton, IL

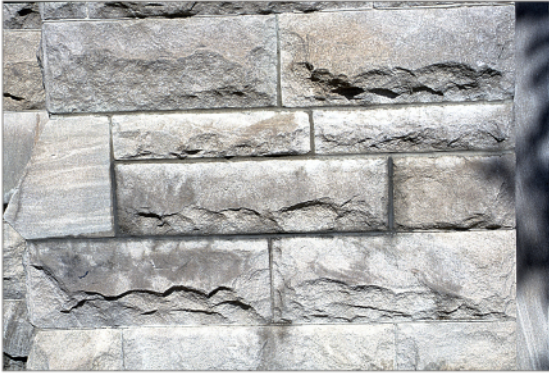
Images of Phase I and Phase II work are shown here. Image 1 is of the test panel for tuckpointing. The grinding of the old mortar is shown in image 2 and on the tall south-west tower (image 3). Patching of damaged limestone is shown prepared in image 4, while the patch of that damage is shown in image 5. Many windows that were no longer functioning to bring in light or ventilation were infilled with stone to match the existing as shown in image 6.
