Carle Foundation Hospital Masonry Upgrade and Vertical Expansion

Urbana, Illinois

Range of Services

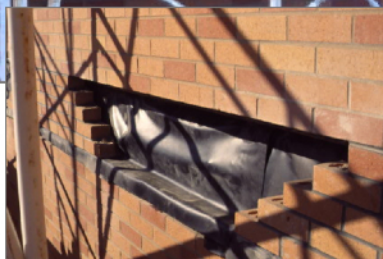
Shelf angle repair

The solution involved investigation of the exterior brickwork problems, along with exploratory openings to expose typical hidden conditions. It was revealed that flashing stopped short of the brick surface, no weeps were installed, and shelf angles were shimmed more than two inches by means of pieces of steel channels to accommodate a concrete building frame that was very much out of plumb. The steel shelf angles were badly detailed at the corners, allowing brickwork to move differentially and crack as noted. Bolts connecting the steel channel pieces to the concrete frame were loose in many locations allowing the brickwork to move down to bear on the brickwork below. These conditions differed on all four elevations of the stair/elevator tower, necessitating different details to respond to conditions as they were exposed during repair. Rapid response was required from our office to keep masonry and iron-worker crews busy. We created over 50 details in the field that became drawings of record and kept the project on schedule for the repair and the vertical expansion. The shelf angles for the basic building elevations were repaired in place by removal of brickwork in five-foot long horizontal sections one foot high in a stagger pattern as shown in the photos below. We were also the masonry consultants for the vertical expansion, where one set of details is all that was necessary for the new construction.

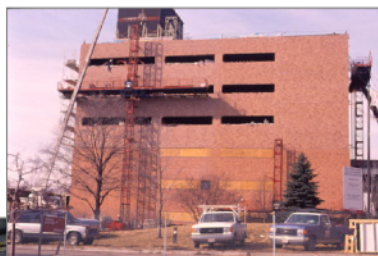
Vertical expansion
