Loomis Laboratory Masonry Rehabilitation

University of Illinois
 Urbana, Illinois

Client: Capital Development Board, Springfield, IL
 Prime A/E: Glerum Wachter Architecture, Urbana, IL

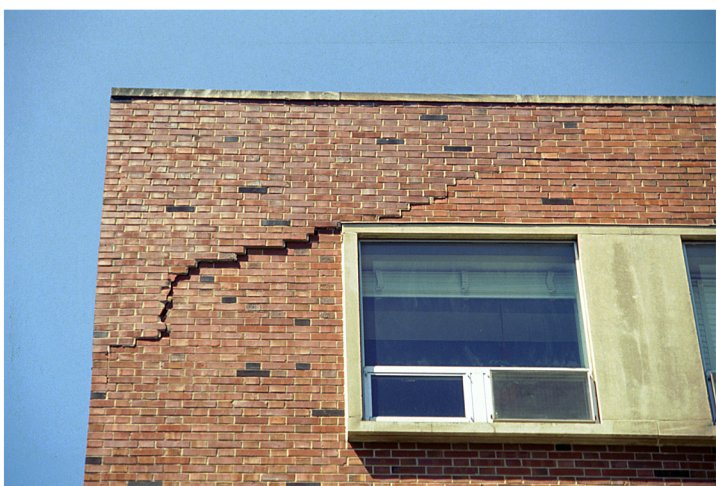
1

This 1950's building is a four story cast-in-place concrete beam and column frame. The exterior wall is composed of three 4 inch thick wythes of masonry. The inner wythe is concrete block, the middle wythe is common brick, and the outer wythe is exterior grade brick veneer. The inner two wythes bear on the concrete floors at each level and are set in-between the columns. The brick veneer is header bonded to the back up center Wythe every sixth course. There are no provisions for brickwork expansion vertically or horizontally.
