The Wolford Apartment Building Masonry Restoration Project

Danville, Illinois

Client: Urban Innovation, Inc. , Chicago, IL
 Architect: BLDD Architects, Decatur, IL
 Masonry Contractor: Otto Baum Company, Inc., Morton, IL

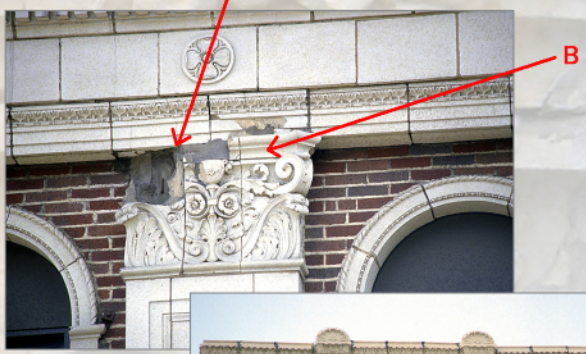
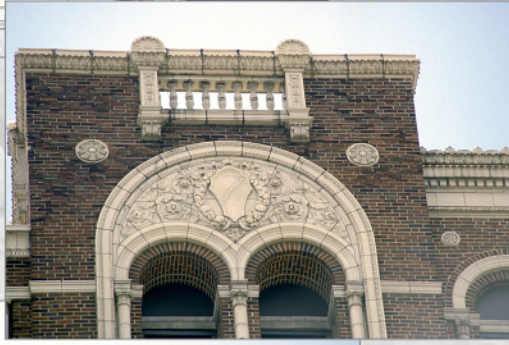
One repair project was implemented in 1986-7: repair of the corner apartment porches. This centered on the terra cotta spandrel that was drooping at three corner apartments, see image A. The terra cotta was removed; the corroded supporting steel pieces were replaced and then the terra cotta was re-hung. See page 2, images 1 and 2. Parapet level brickwork that was water damaged and bulging was replaced on two elevations.
