First Presbyterian Church of Champaign Masonry Restoration/Preservation

Champaign, Illinois

Project Overview

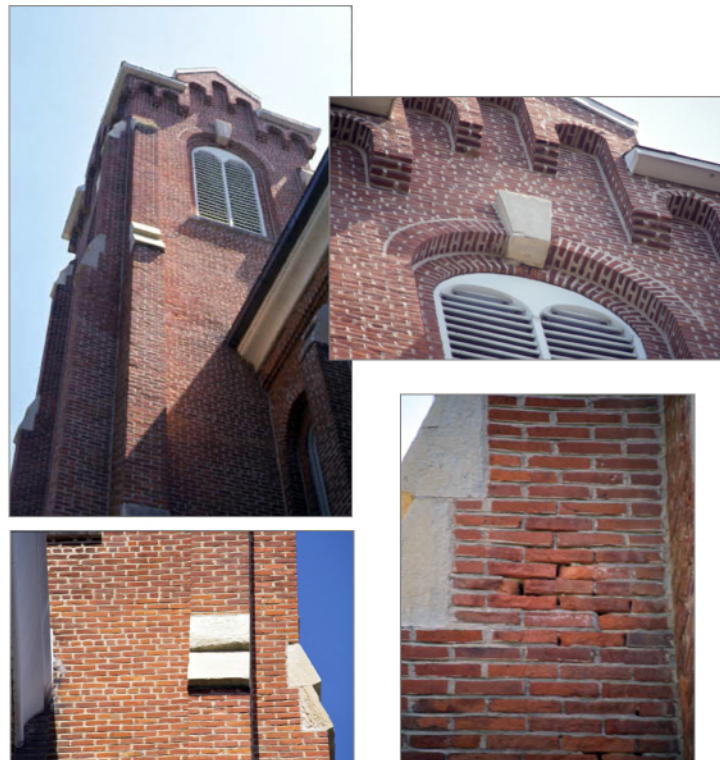
Total masonry preservation/restoration project involving brickwork, mortar and limestone detailing. Damage included deteriorated mortar, spalled and eroded brick units, spalled and eroded limestone buttress caps, window sills and wainscot caps. See Images below. Brick units in some locations had become very porous and needed to be replaced. A complete tuckpointing was done, all limestone pieces were replaced with copper flashing installed below each piece. Corroded steel lintels were replaced. Care was taken in the selection of replacement brick, mortar and patch materials for stone and brick where required. Deteriorated brick and stone conditions are shown to the left.

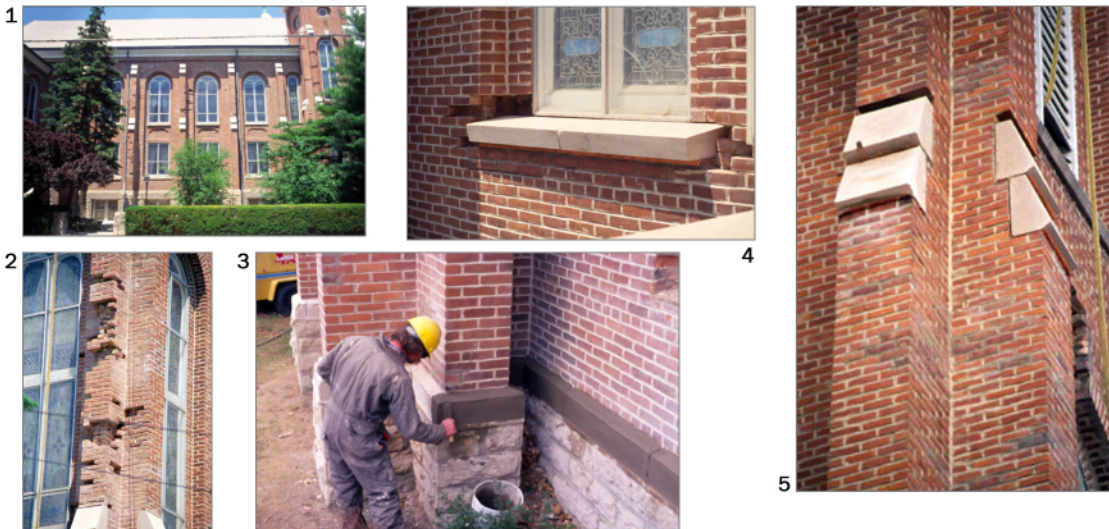
Construction images are below. South Elevation brick replacement is shown in images 1 and 2. Wainscot cap repair is shown in image 3. Limestone replacement for window sills and pilaster caps is shown in images 4 and 5 respectively.
